October 24, 2016

Re: Geotechnical Engineering Assessment of Dairy Farm Storage Pond Berm  
4207 West Linwood Avenue, Turlock, California  
*SFB Project No.: 727-1*

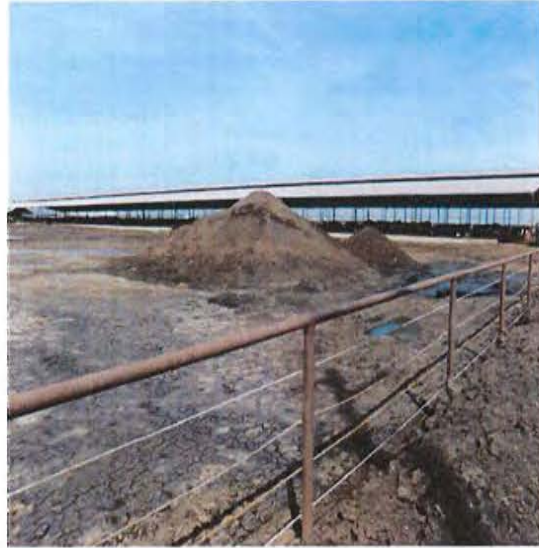
Photo of manure piled in a corral.

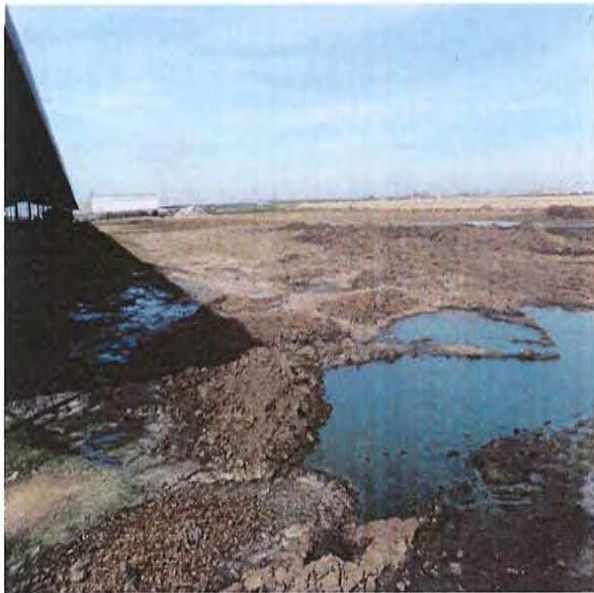
Photo of ponding in a corral.

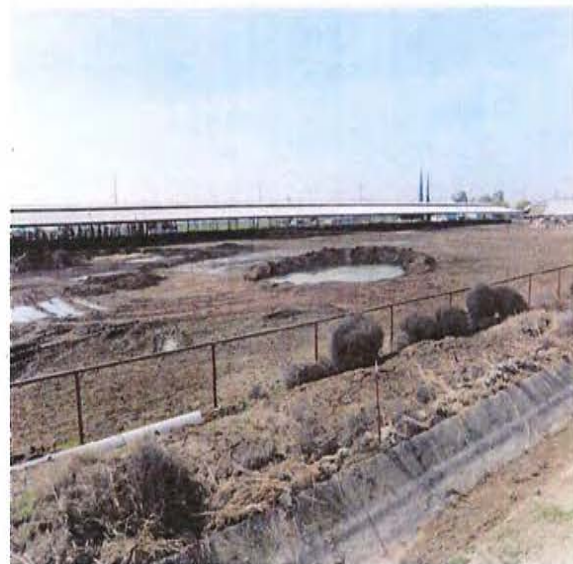
Photo of a crater in a different corral with standing water.

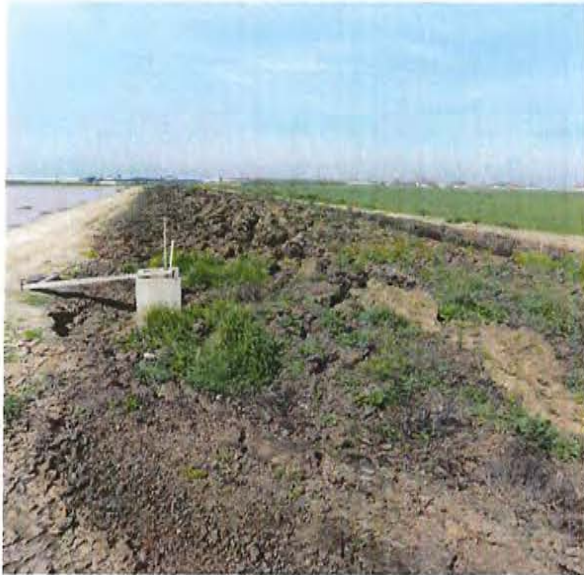
Photo of the settling basin. Note it is extremely full.

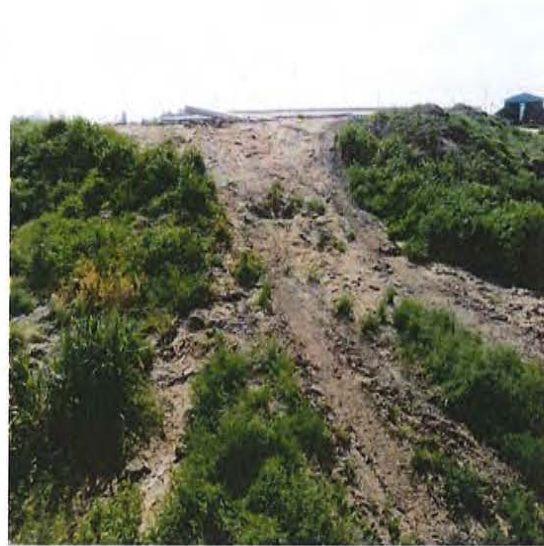
Photo of the settling basin embankment where wastewater overflowed onto adjacent cropland.

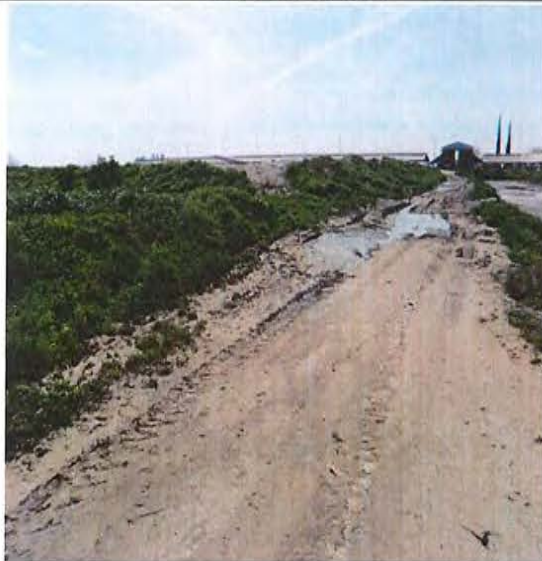
Photo of process wastewater at the toe of the embankment from the overflowing settling basin.

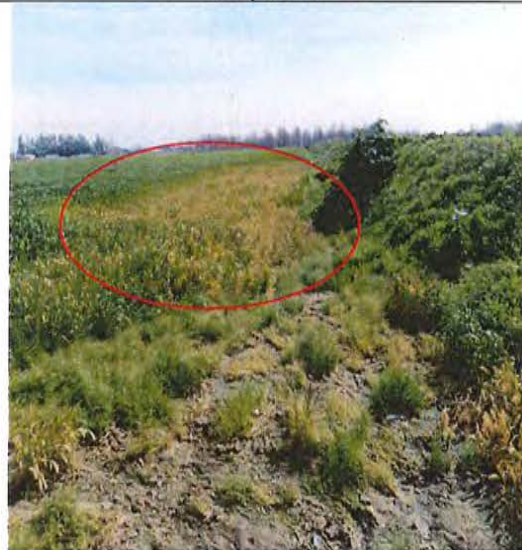
Photo of cropland that was affected from the overflowing settling basin. Note that the crop circled in red is burnt.

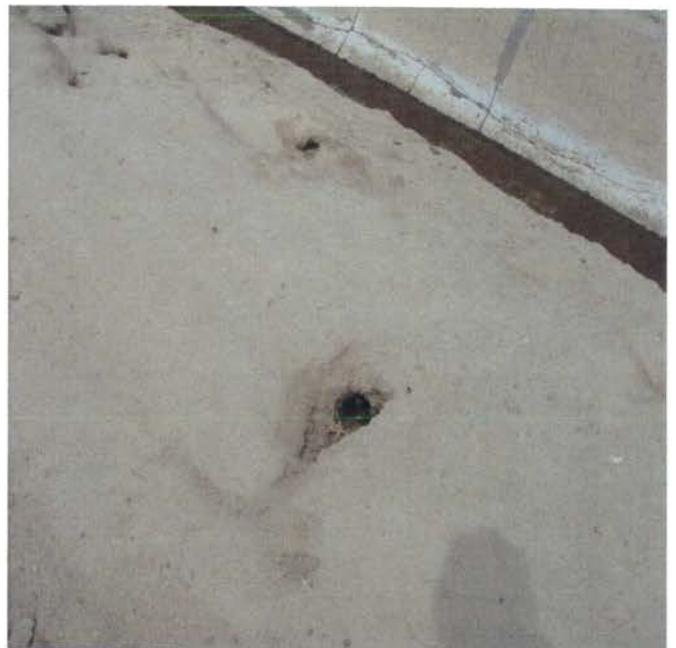
Phone 6: Holes on the berm of storage lagoon

The corrals should be graded and sloped to divert corral runoff into the storage lagoon. The manure storage area should have a drainage system to direct runoff into the storage lagoon. The wastewater storage lagoon should be maintained free from holes and animal burrows.

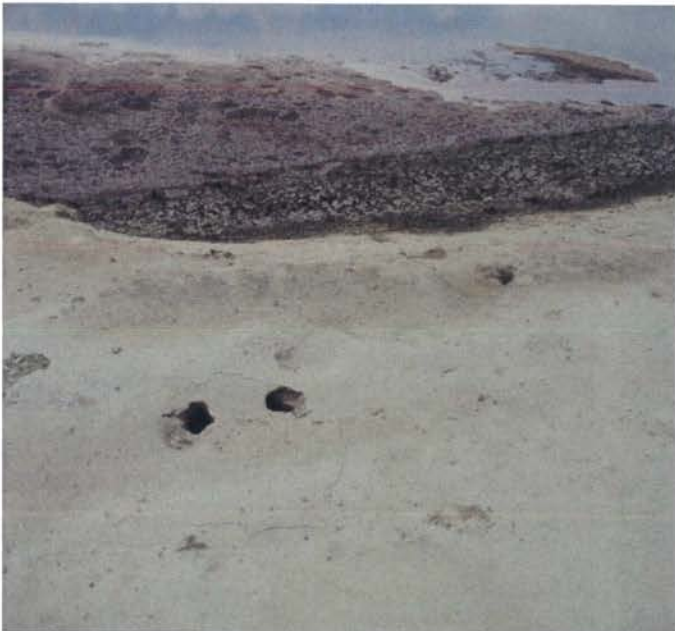
Phone 7: Holes on the berm of storage lagoon

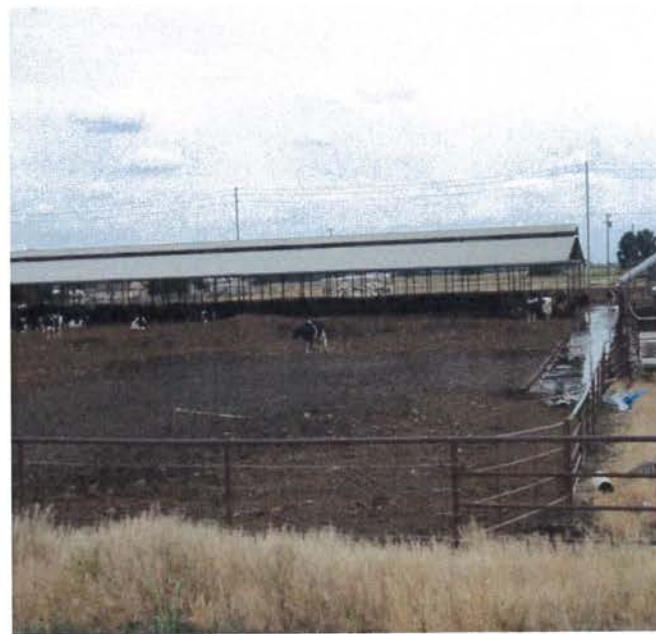
Phone 12: North side corral with sign of corral ponding

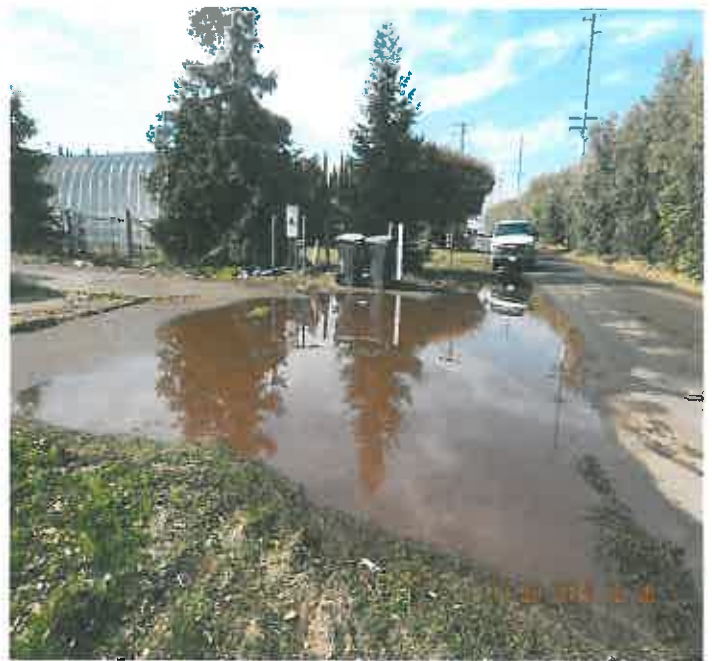
Photo 2: Wastewater ponding on south side of Linwood Avenue (east to west view)

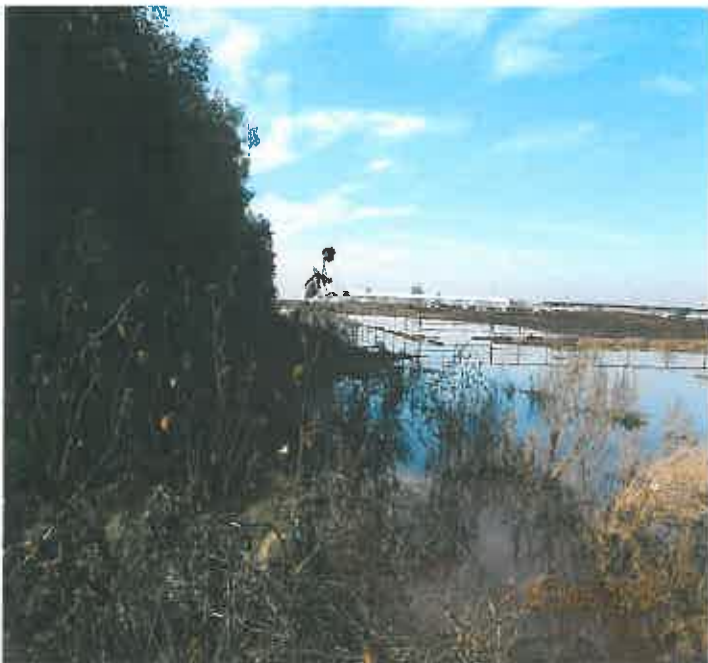
Photo 3: Wastewater ponding in west side corral

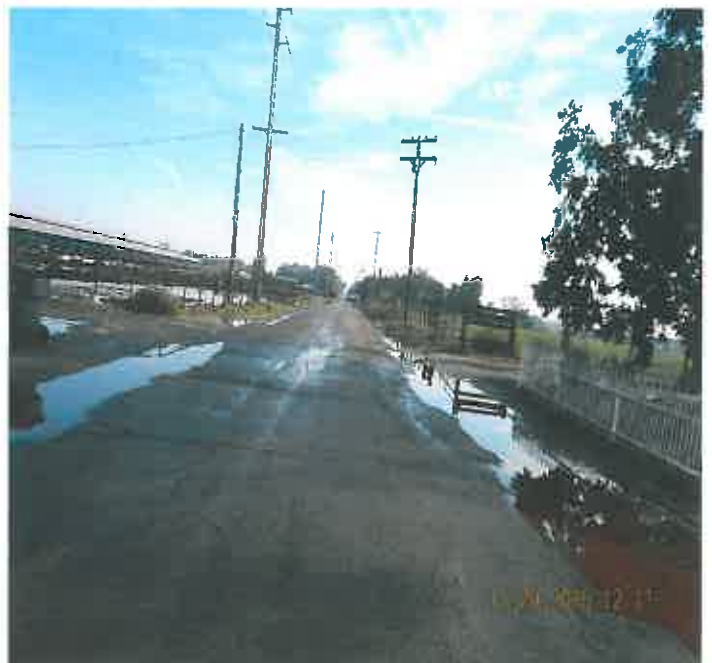
Photo 4: Wastewater ponding along Linwood Avenue (west to east view)

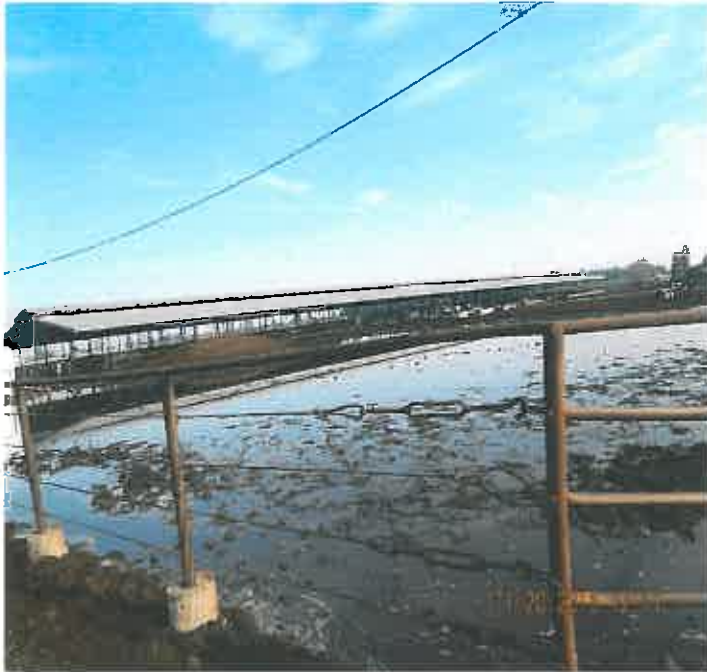
Photo 5: Wastewater ponding in south side corral

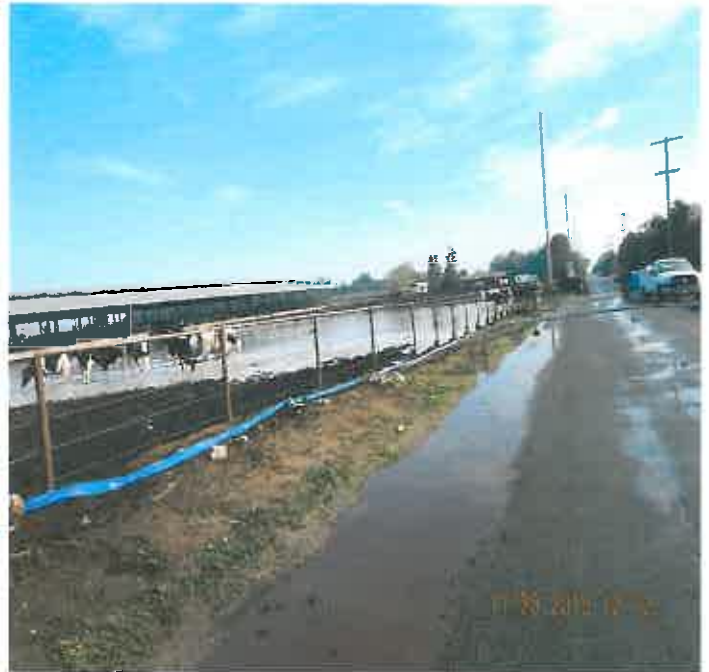
Photo 6: Wastewater being pumped in south side corral; wastewater being pumped back from residential areas in to corrals and then to pond

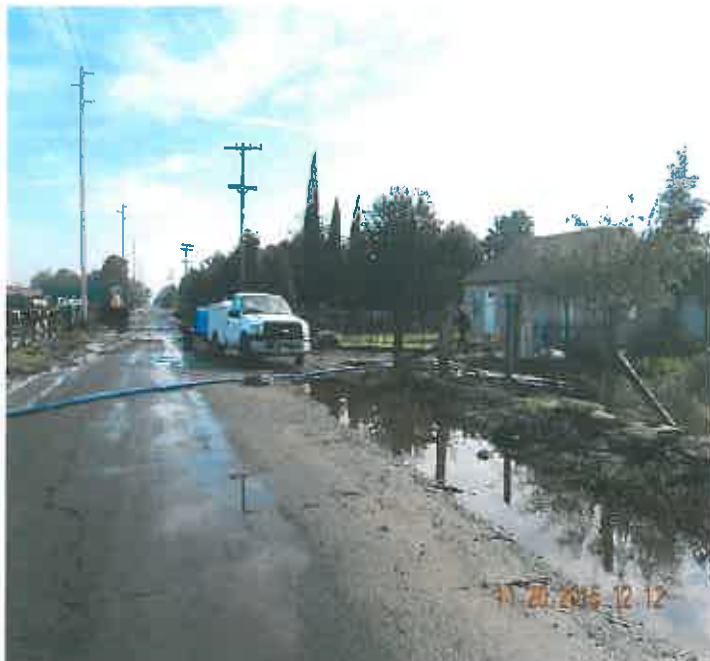
Photo 7: Wastewater being pumped from residential areas to corral (west to east view)

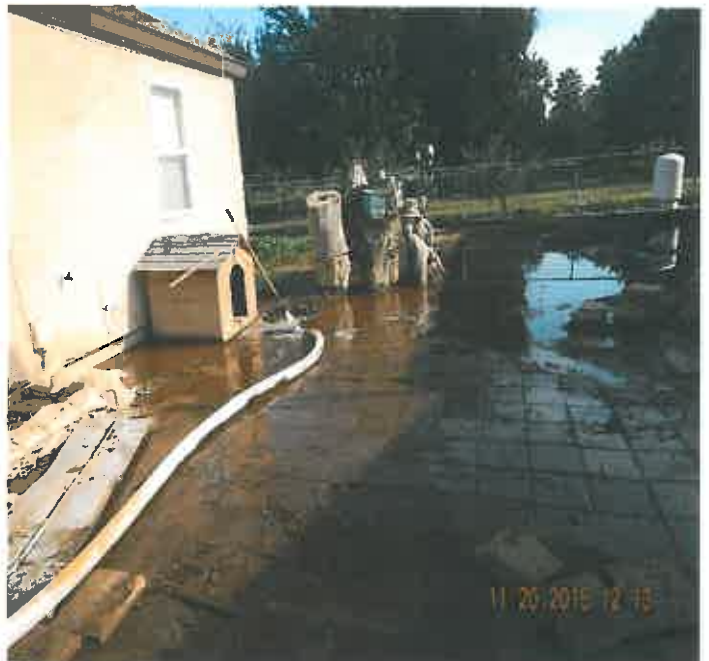
Photo 8 Wastewater being pumped from residential areas to corral

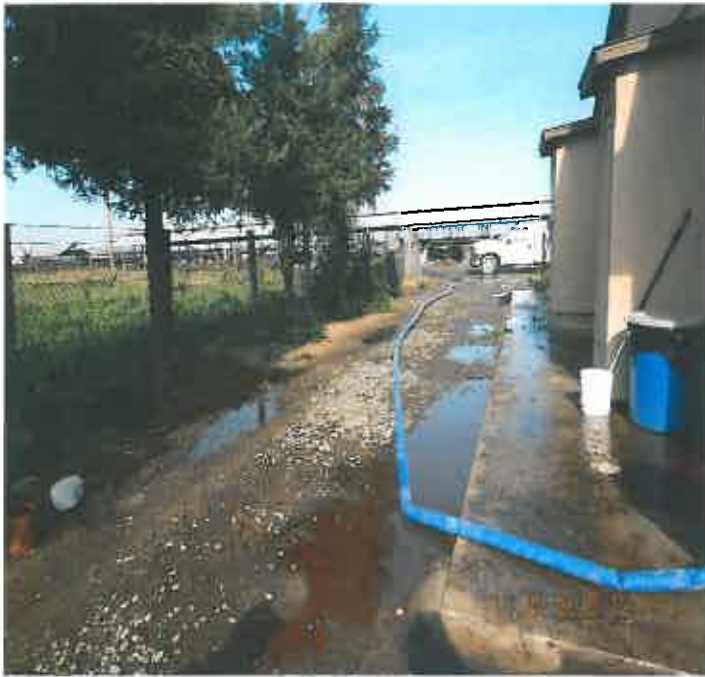
Photo 9: Wastewater being pumped from residential areas to corral

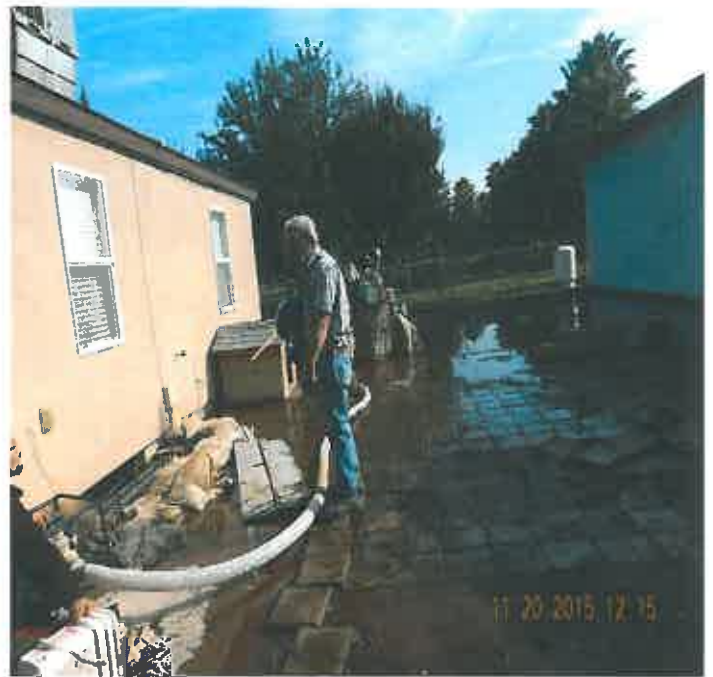
Photo 10: Wastewater being pumped from residential areas to corral

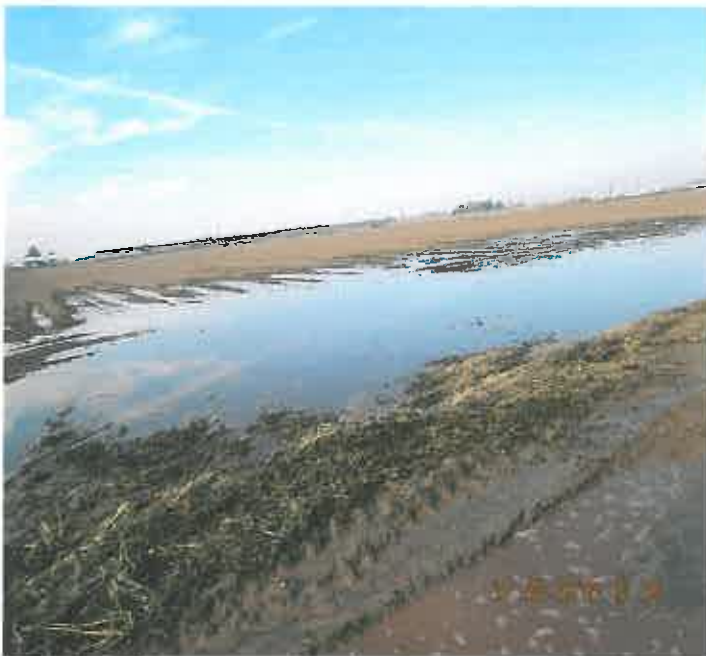
Photo 11: Wastewater directed to cropland

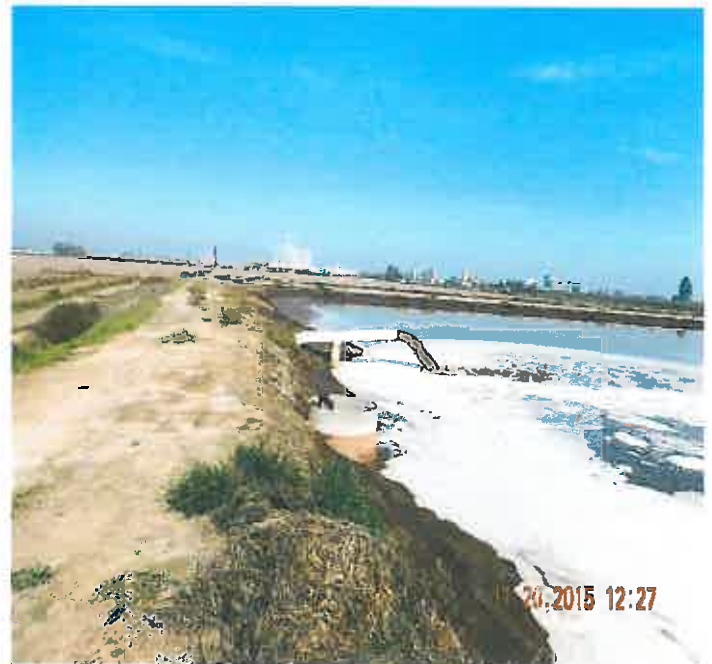
Photo 14: Wastewater from corrals being pumped back to lagoon

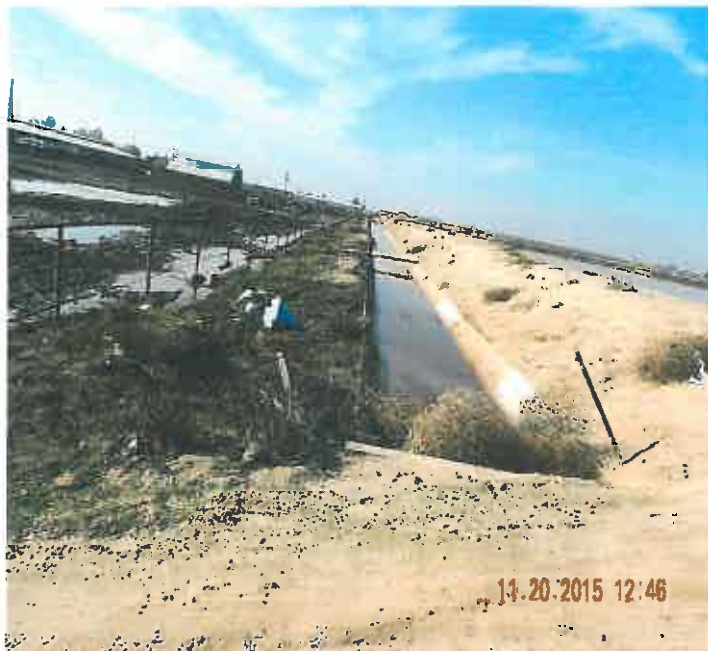
Photo 19: TID canal south of the lagoon (east to west view)

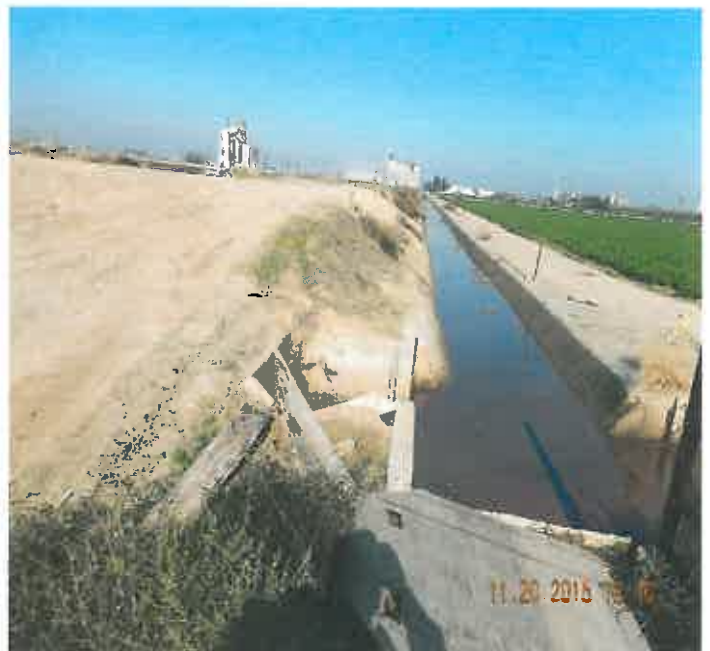
Photo 20: TID canal east of the lagoon (west to east view)

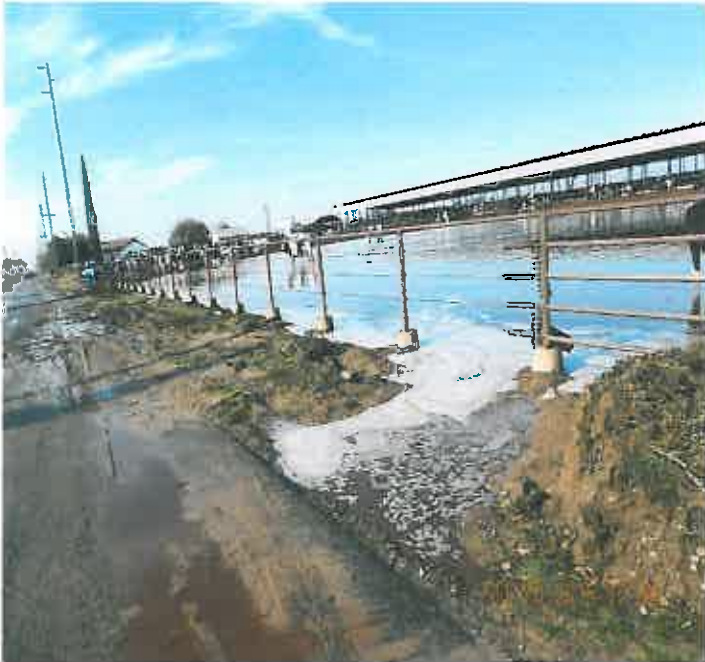
Photo 21: Wastewater ponding in south side corral and on road side (east to west view)

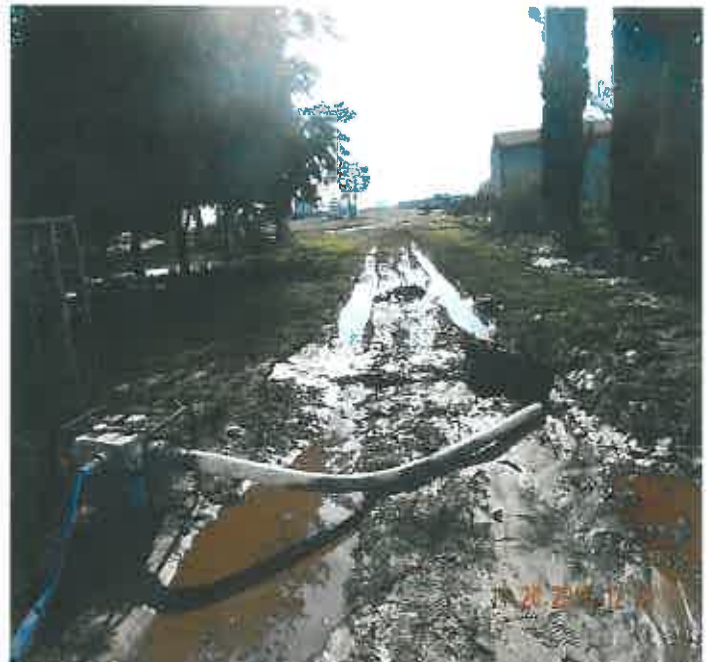
Photo 22: Wastewater being pumped from residential area into the corrals

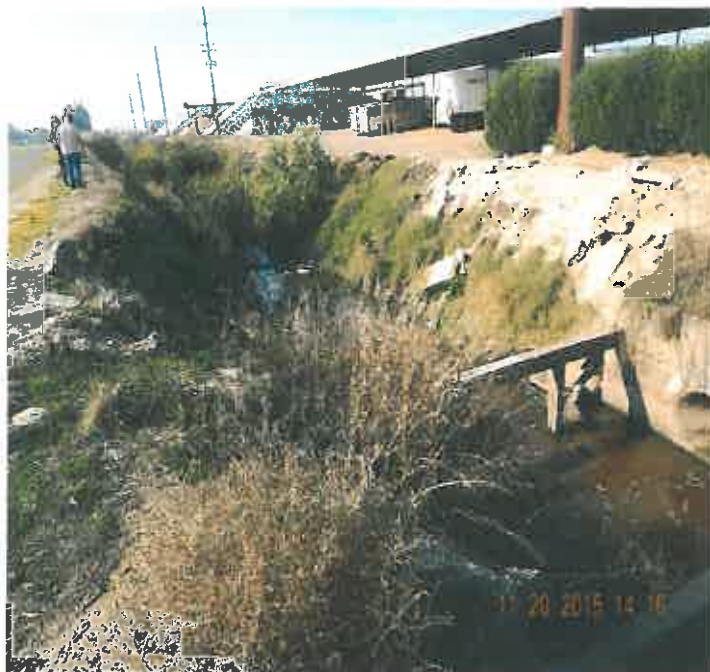
Photo 25: Wastewater in Harding Drain

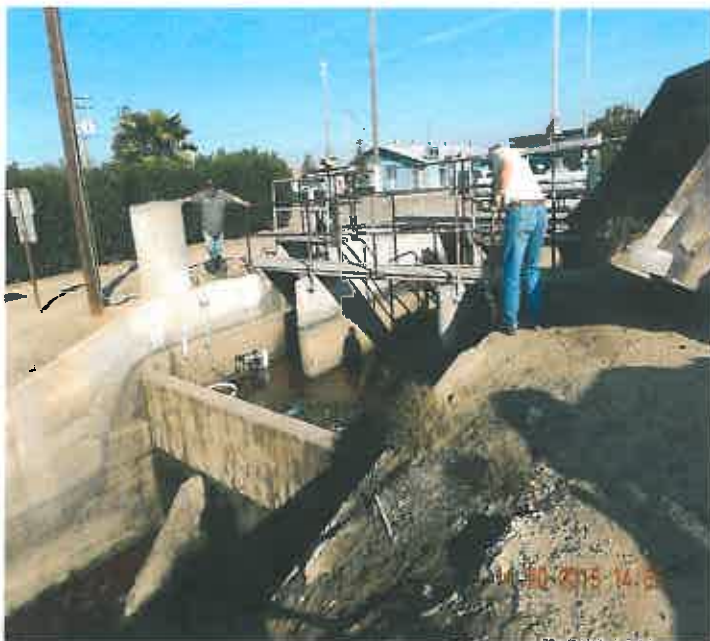
Photo 27: Wastewater in Harding Drain; the leaking area was being closed

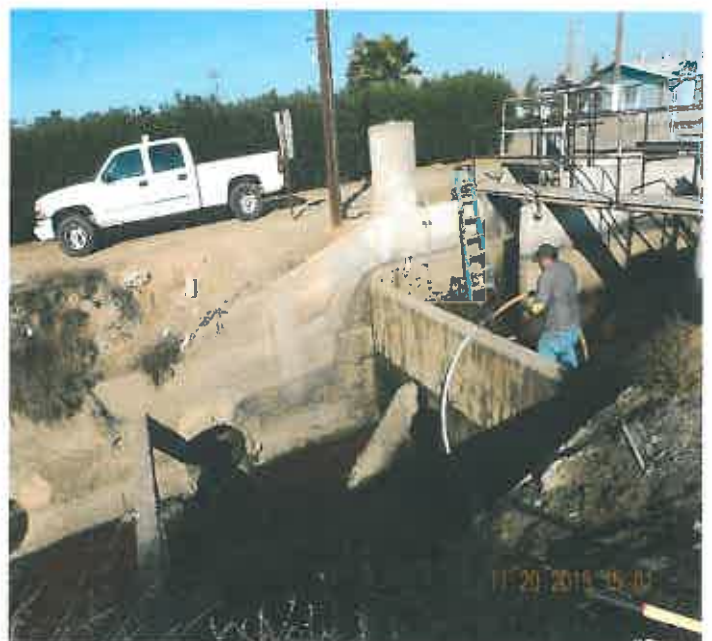
Photo 28: Wastewater in Harding Drain: attempt to pump wastewater from the drain
